Later Ukrainian Log Houses (1915-1940)

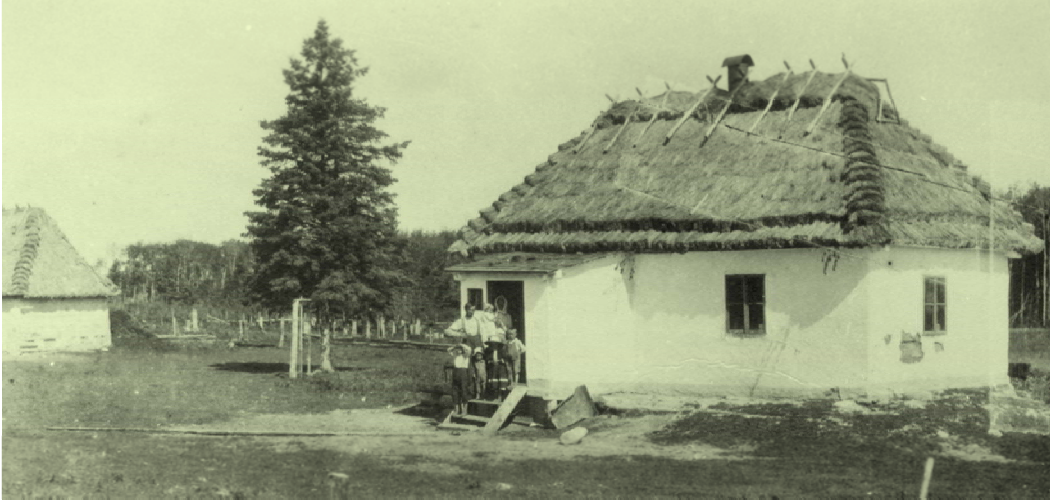
Figure 13

The second homes built by the Ukrainian settlers in the Interlake were larger and much more carefully constructed than the initial structures. This example was photographed in 1918 in the Gimli area. (Provincial Archives Manitoba)

The new houses differed, primarily, in their size and the sophistication of their construction (Figure 13). For several years prior to construction, large, carefully selected trees would be cut and hauled to the site of the new house, where they would be peeled and allowed to cure or dry to prevent later shrinkage or rot. During construction, the help of a local carpenter was usually acquired to help face or square the logs and to cut the notches. In the Eastern Interlake, the dovetail notch was by far the most popular joint for new homes. These later houses were more likely to have a white lime or coloured finish applied to the mud plaster than the original homes and decorative bands or designs were also often painted on the walls. Other improvements included a properly thatched roof, lumber floors and ceilings and manufactured doors and window frames.

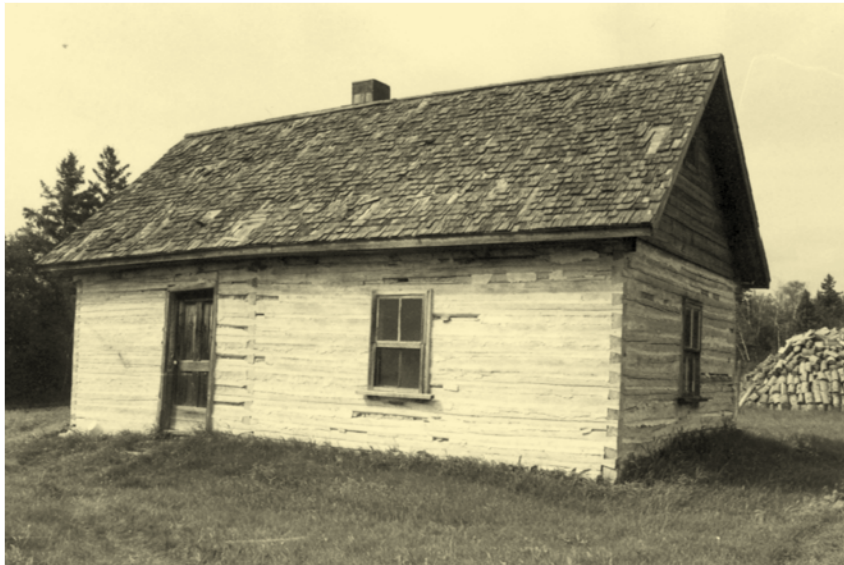
Figure 14

The Stelmach house, SW 27-24-3E. This residence is a typical example of the homes being built during the 1920s. Although no longer occupied, the house and property are well cared for and the site is probably the best-preserved Ukrainian farmyard in the entire planning district.

There are several surviving examples of this type of home in the planning district. One of the better ones, located in the Shorncliffe district, at section SW 27-24-3E is Galician in style, and is part of a very well preserved set of farmstead buildings (Figure 14).

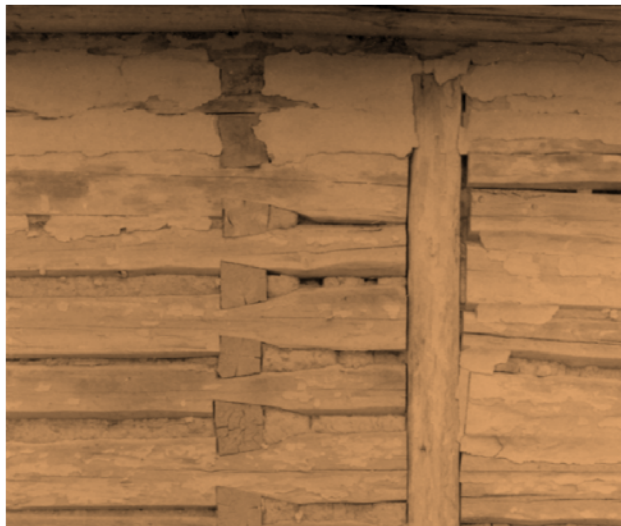
Figure 15

Stelmach house: sidewall - interior wall connection.

The house, situated at the top of a small hillock, and resting on a foundation of loose stone, was constructed of logs cut, shaped and fitted entirely by hand (Figure 15). The tight fit of the logs precluded the need for the usual thick mud plaster coating. The walls were simply chinked and then coated with the usual whitewash finish.

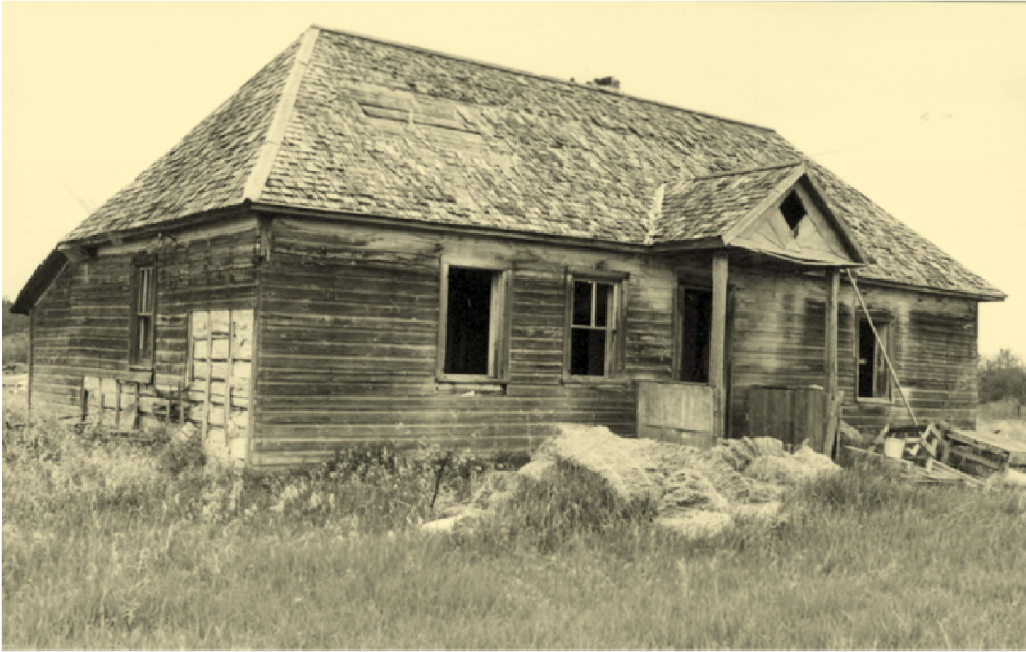
Figure 16

The former S. Cherniak residence, SW 11-11-1E. By the late 1920s, wooden roofs, siding, and rear additions could be found on many of the Ukrainian log homes in the Eastern Interlake.

By the late 1920s, major changes in building styles appeared and the traditional Ukrainian log house began to lose some of its cultural distinctiveness. A large Bukovynian log residence several miles northwest of Gimli features a number of transitional features, (Figure 16). Interior changes include wallpapering of the walls, and beneath the siding and the presence of thin rail rafters suggests that the structure originally had a white mud plaster finish to the walls and a thatch roof.

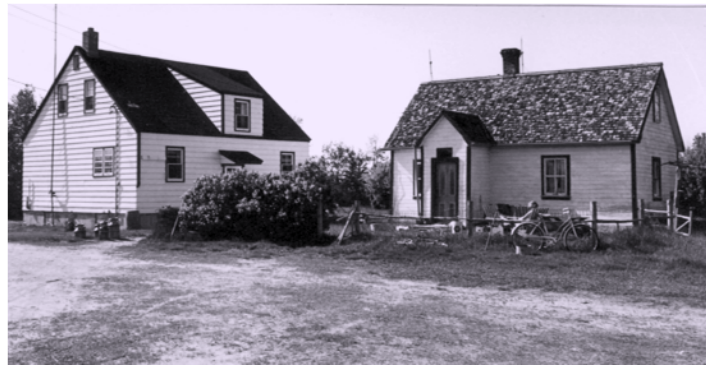
Figure 17

Wood frame homes such as the one on the left began appearing during the 1930s. The structure on the right is the earlier log home. These examples were found in the Dnister area near Gimli.

By the 1930s, frame construction was becoming more affordable and pattern book frame lumber houses devoid of any ethnic character were replacing the early log homes (Figure 17).
